Jordan's Point Park

HISTORIC WALL CONDITION ASSESSMENT REPORT

MARCH 2020

McMullan & Associates
Douglas E. Bond, PE
Reston, Virginia
March 12, 2020

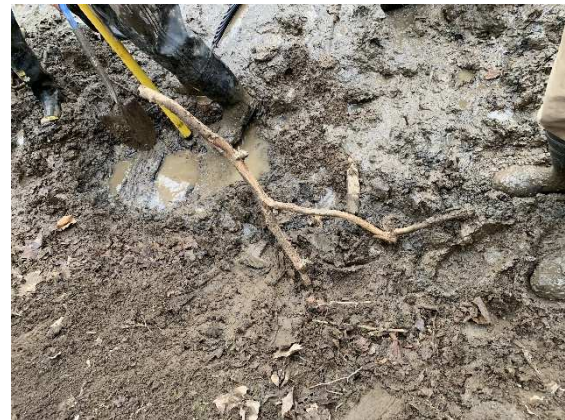
The water over the timbers was about 18-24 inches deep before pumping. Only one timber could be seen in the sediment prior to pumping.

Figure 8 - The sediment above the timbers was excavated by DPW personnel and can be seen in the photo.

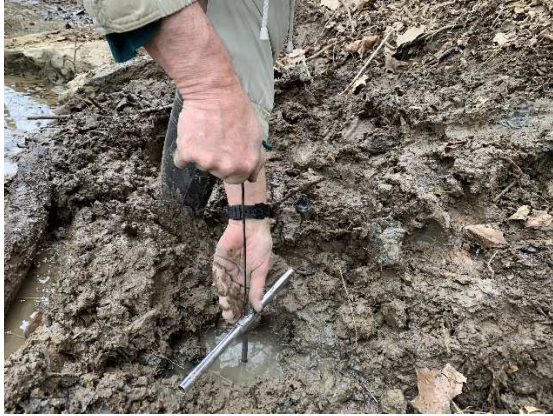
Three groups of timbers were observed to extend perpendicular from the face of the wall about 20 feet into the tail race. The timbers are consistently 8"x8" and there is about 12 inches clear between the timbers. Samples of the timbers were extracted in 6 locations by Mr. Loferski, noted E-1 through E-6 on the sketch below which also indicates the plan locations of the excavations. The cores were taken with an increment bore tool. All the timbers were found to be very difficult to core, with one being so hard that extracting a core was not accomplished.

Figure 9 - Cores were extracted from several of the timbers using an increment borer. The cores were taken to the lab at Virginia Tech for species identification.

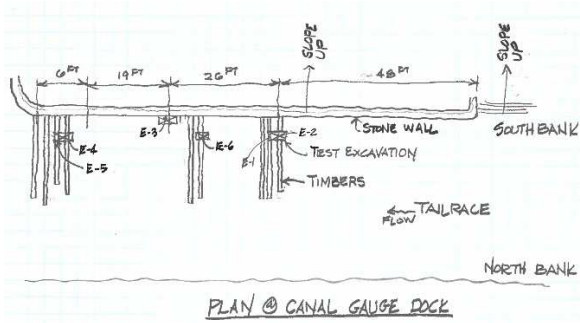
Figure 10 - Field Sketch - Plan of the Dock Excavation with locations of timbers and test pits

Timbers were only found at the locations indicated in the sketch and many of the areas between the timbers were probed with the rebar at about 2 to 3 inches on center in an attempt to find other timbers, but none were found. We assumed that these groups of the timbers extend from the wall and formed part of a foundation for the wall in the middle of the race that can be seen in the 1866 historic photograph included previously in this report.

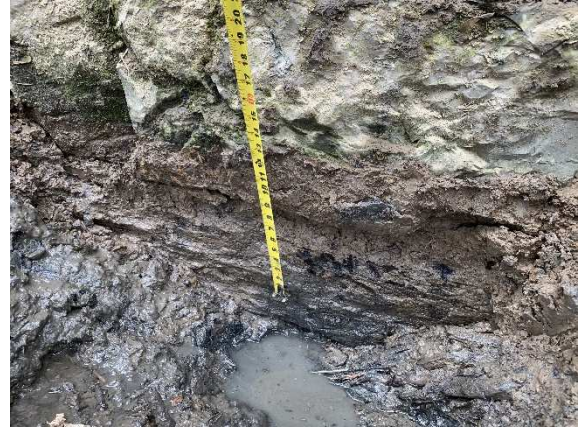
Along the base of the wall, there is an 8" deep timber that runs flush with the face of the stones. The perpendicular timbers which extend into the tailrace run underneath this face timber.

Figure 11 - An 8x8 inch timber was seen to run parallel to the wall under its face. End of the tape measure is in contact with the timber.

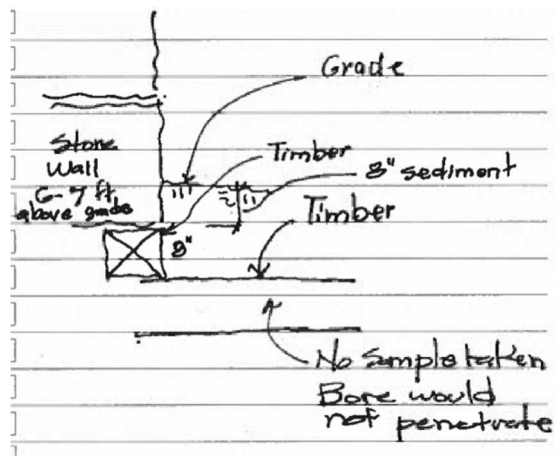
Figure 12 - A field sketch of the timber at the face of the wall was prepared to show how the cross timbers run underneath

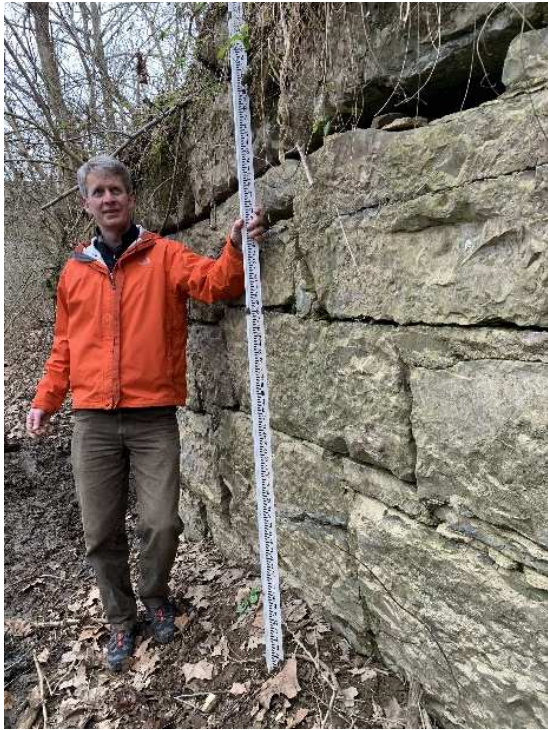
The wall was measured to be about 6'-6" above the timber foundation. The tilt of the wall was measured in several locations and found to be up to 8" of horizontal within 6'-6" vertical. This tilt is quite noticeable when standing next to the wall.

Figure 13 – Field sketch at base of stone wall showing 8” timber parallel to the wall and cross timbers below at Location E-6

This masonry is in fair condition. There has been loss of mortar in the joints as well as deterioration of the stones, but the wall remains in plane with no bulges or other distortions. There is a significant (8-10 degree) tilt to wall, probably as a result of lateral earth pressure from the slope behind the wall. It appears that the slope has increased since the 1866 photo, and it is assumed that when the rail grade was installed after the 1877 survey, the grade was raised to level.

1. Remove some of the slope behind the wall to provide a gentler slope, similar to that seen in the historic photograph. This will reduce the earth pressure on the wall and still promote ground run-off to flow over the wall.
2. Leave the wall in its current tilted position. By reducing earth pressure and keeping the foundation timbers submerged, the wall should remain stable for some time.
3. Remove some of the vegetation at the top of the wall to prevent it growing into the masonry.
4. Do not allow any vegetation to grow through the wall.

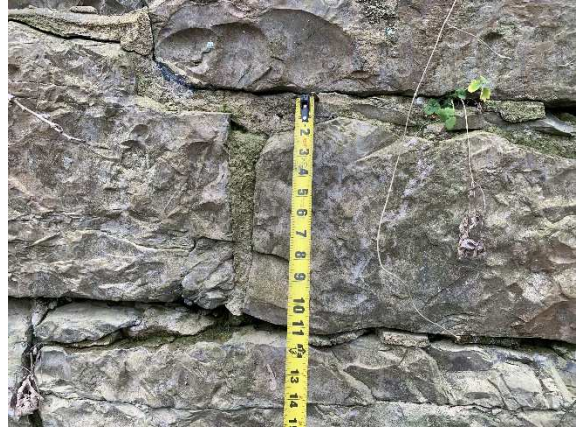
The stones have a hammered finished face and appear to be quarried from a sedimentary type rock. There are horizontal planes in some of the stones that indicate that the stones have some minor deterioration in the bedding planes which can be expected from this kind of stone. Random mortar bed joints between stones were measured and found to vary from 0 to 1”.

Figure 14 – Close-up view of the Dock Stone Masonry

Mortar joint widths varied, from zero up to about 1-inch in width. Smaller stones were used as chinking between the larger stones in some locations.

The mortar is in fair condition and was found to be fairly hard and not crumble when scraped with a trowel. There is missing mortar in many of the joints. Some pieces of mortar that were removed from the wall could be broken by hand. The sand in the mortar appears to be consistent and well graded. Given its condition, it is likely that some hydraulic lime or natural cement is contained in the mortar. A mortar analysis would provide more detailed information.

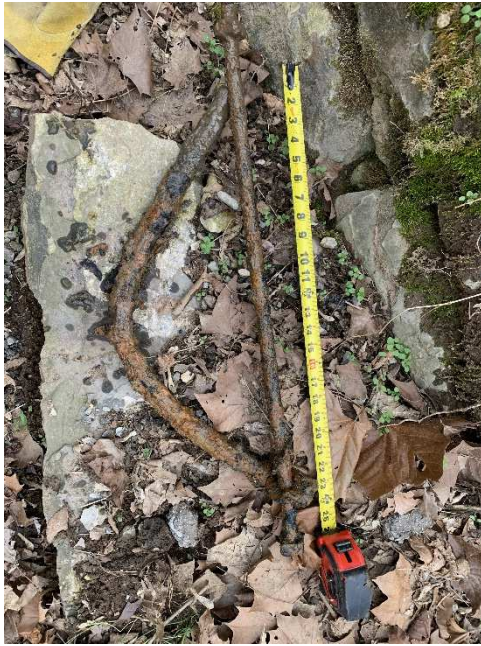
Two iron rods were found by the DPW crew while excavating in the sediment. These are assumed to have been used to tie timbers together for some structure in the past.

Figure 15 – Iron bars found at the bottom of the wall

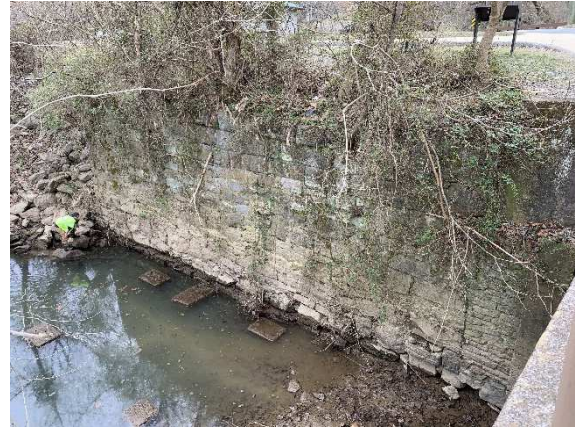
At the Mill foundation wall, two pumps were used to draw down the water. The water was lowered about 18-20 inches, but could not be lowered further due to the inflow of water from western side of the bridge.

Figure 16 - Foundation wall for the Mill. The stones in the tail race were likely foundation stones for the turbine.

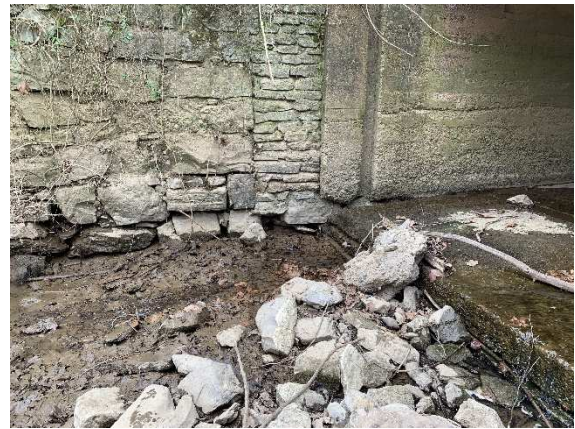
At the base of the bridge foundation, there is a concrete slab placed on timbers that are exposed on the eastern edge. In the concrete abutment, there are vertical slots on the north and south sides that appear to be for the use of wooden boards to temporarily dam the water and allow for repairs of the mill turbines.

Figure 17 - Slab at the base of the bridge was placed on timbers. There is a slot or notch in the concrete abutment, likely used to slide in boards to dam the water during repairs to the turbine.

In order to lower the water further, larger pumps or a temporary sandbag cofferdam would be needed.

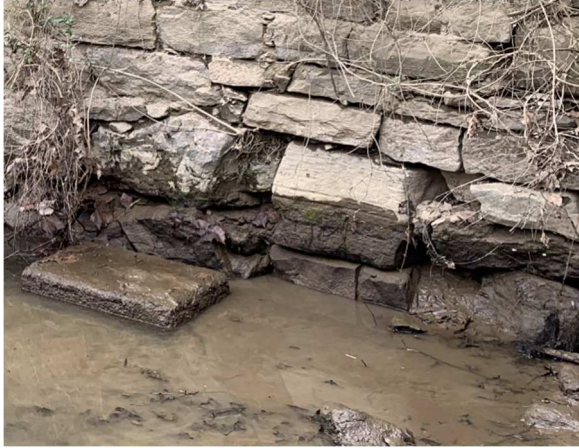
Figure 18 - Stones at the base of the Mill wall

We were able to probe the ground in several places in front of the Mill wall with a reinforcing bar to search for timbers. The rod was unable to penetrate more than a few inches of sediment in any one location due to the rocky surface below the sediment. We could not determine if this was natural rock or creek stone.

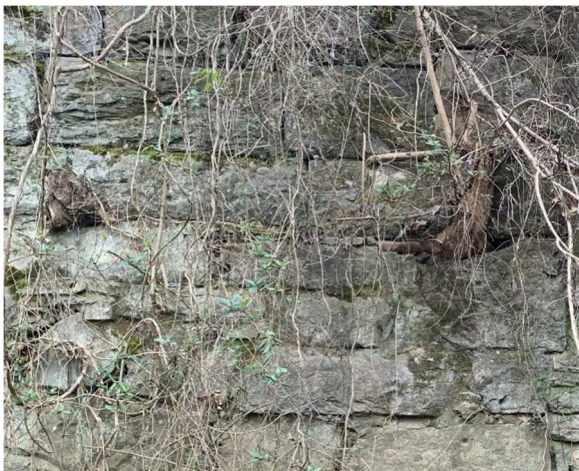
Vegetation was observed growing through the wall, and has been cut back in some locations.

Figure 19 - Vegetation was observed to be growing in the joints between the stones at the Mill Foundation wall

evidence of foundation deterioration. There has been a loss of mortar in the joints between the stones, but no large cracks or bulges in the stone masonry were observed. There does appear to be some vegetation growing from the joints between the stones. If left untouched, this could grow to the point that it will lead to damage of the masonry. There are a number of trees at the top of the wall with root structures that may be working their way into the masonry.

1. Remove any vegetation that is growing through the wall. Don't disturb the masonry by pulling the roots out. Coat any remaining roots with herbicide.
2. Remove vegetation at the top of the wall, but do not damage any masonry by using excessive force. A railing or fence may have to be considered since removing the vegetation may result in a falling hazard.

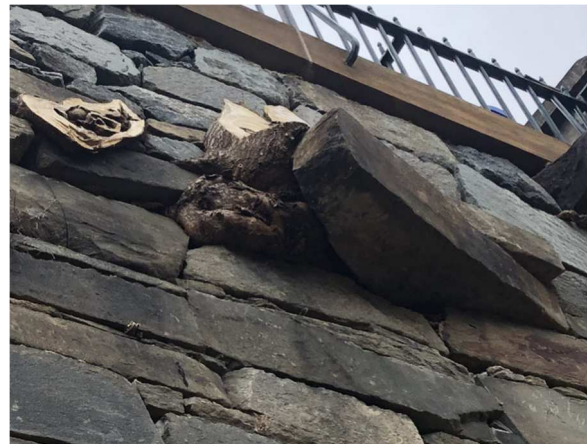
Trees that grow into masonry cause damage. See the image below for an example in another McMullan project where a stone was pushed out of a wall from tree roots.

Figure 20 - Example of wall damage by vegetation, This stone was pushed out of the plane of the wall by the growth of tree roots (located at the C&O Canal in Washington DC)
