Jordan's Point Park

HISTORIC WALL CONDITION ASSESSMENT REPORT

MARCH 2020

McMullan & Associates
Douglas E. Bond, PE
Reston, Virginia
March 12, 2020

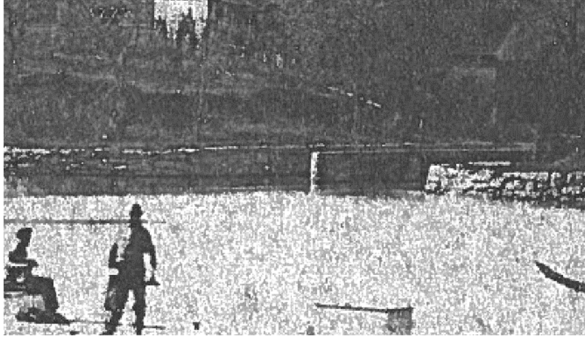
Figure 3 - Enlargement of the 1866 Photo with the Gauge Dock in the background. Note the wall in the center of the tail race, and the slope of the grade behind the south bank wall,

It is important to note in the photo that the earth behind the wall on the south bank appears to be nearly level for several feet to the south before it slopes upward.

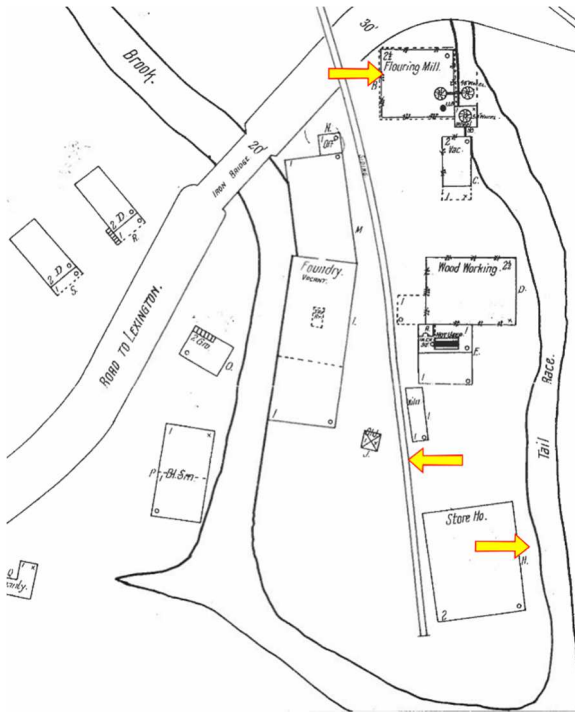
A later survey, date unknown, shows the correct location of the rail line located north of the mill, as well as a spur line located south of the mill that runs to the east. This is important because the grade would have to be level for trains to operate on the spur, and the current grade behind the gauge dock wall is much steeper than indicated in the 1866 photograph. Also, the Gauge Dock does not appear in this survey, and has presumably been removed.

Figure 6 - Survey of Jordan's Point, date unknown but assumed to be after 1877. There is a rail spur located to the south of the Mill and the Gauge Dock has been removed (left pointing arrow).

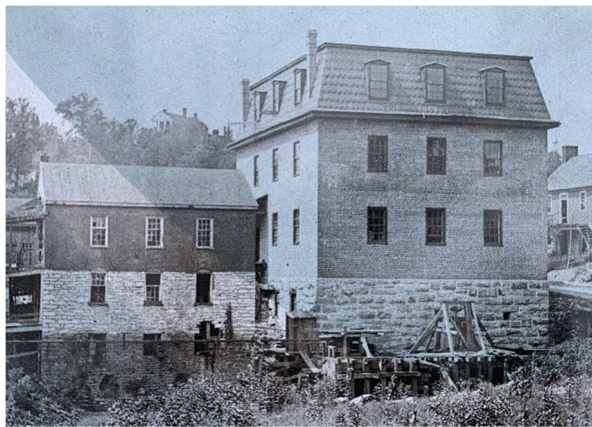
The Mill building wall originally extended above the bridge as indicated in the photo below, but has been lowered to nearly match the elevation of the bridge.

Figure 7 - The Mill building foundation wall is seen to extend above the grade of the roadway

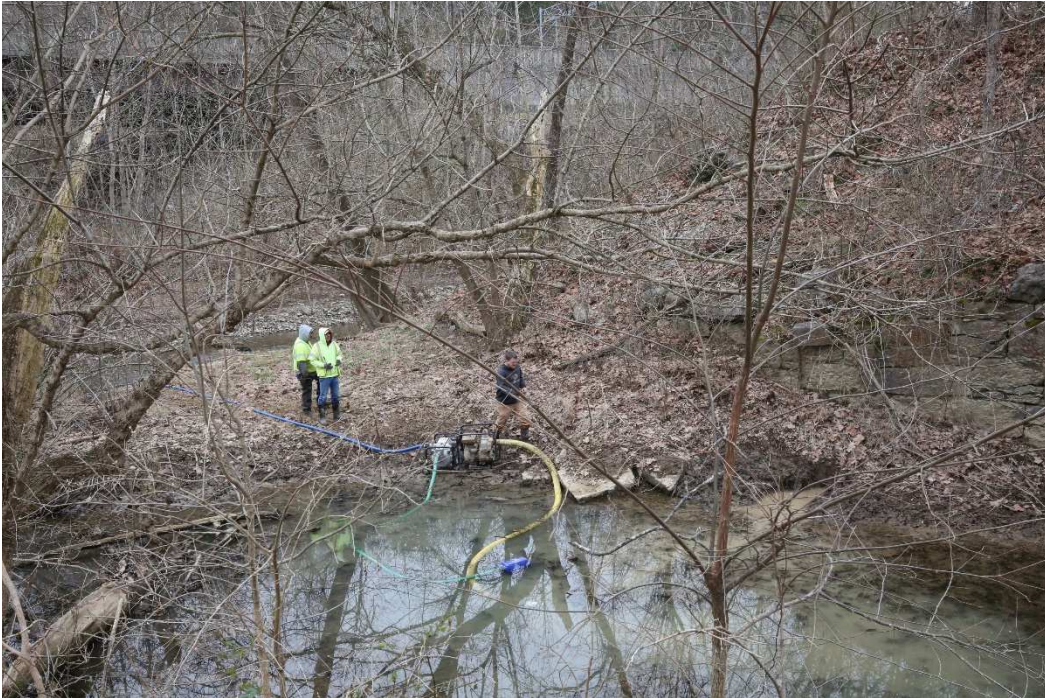
Photograph 1: Workmen using pump to dewater the site. The stone wall is visible on the right.

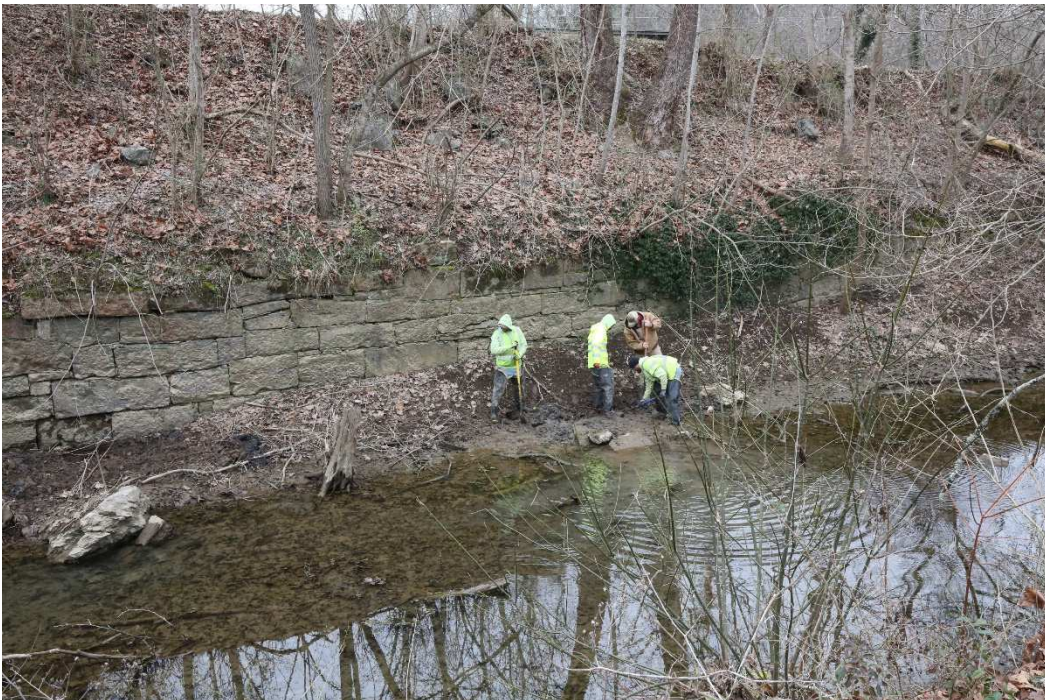
Photograph 2: Workmen digging access hole to timber. Stone wall is visible behind workmen.

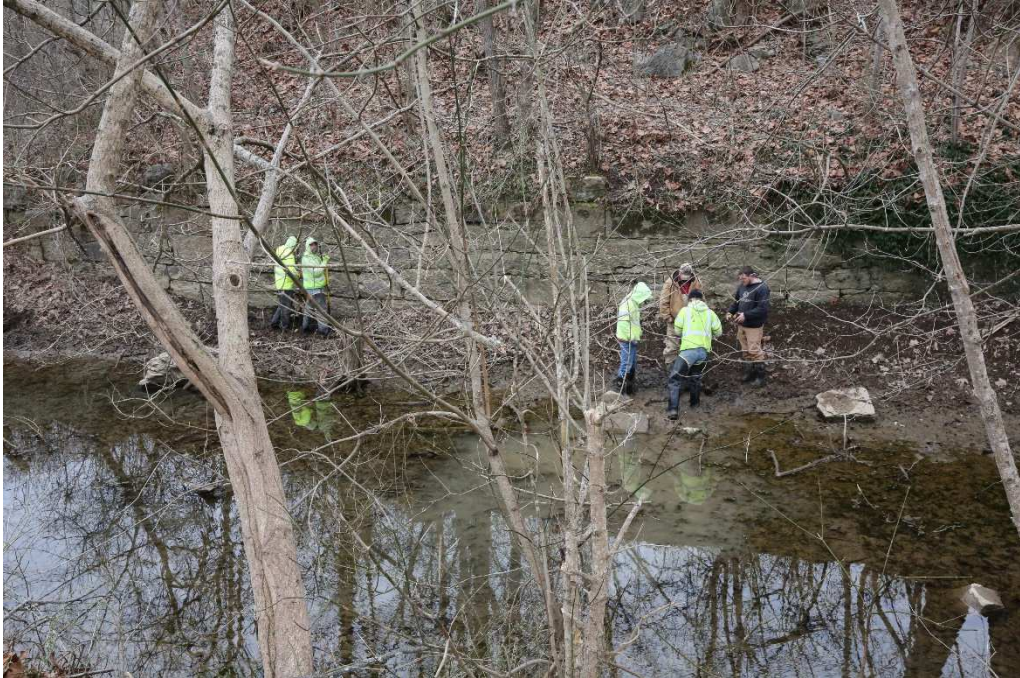
Photograph 3: Workmen digging two timbers.
